MEMO

RE: Black River inspection by boat on August 16, 2024

Black River Inspection Trip by Boat
Aug. 16, 2024

**PHOTO LOG:
BLACK RIVER INSPECTION BY BOAT
NEWSVT
Aug. 16, 2024**

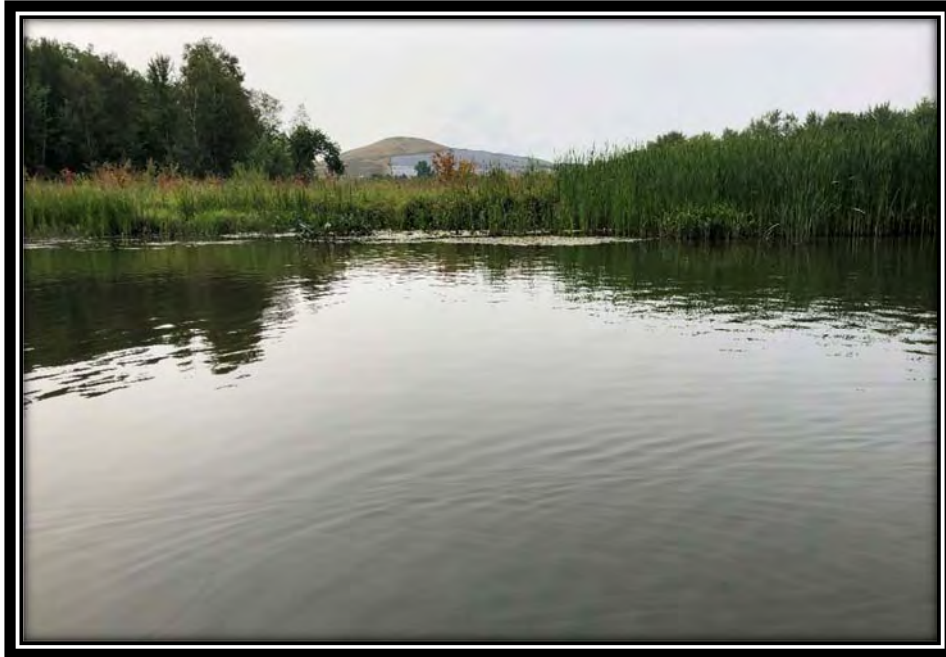
Photo #1: Looking south toward top of Phases 1, 2 shortly after launch from Airport Rd.

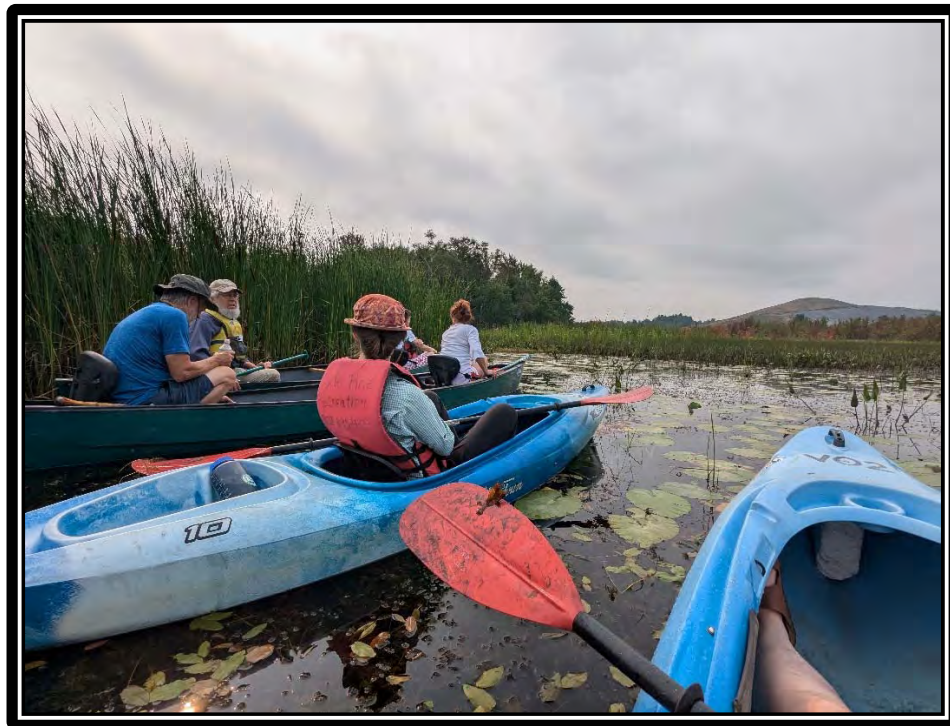
- **Main river:** There were no signs of water quality impacts from the landfill.
- **Backwater areas:** This year, we were able to paddle quite far into the northeast backwater to our usual turnaround point about 400 feet in from the river, and roughly about 400 feet north of the closest edge of Unlined Area A. We saw no signs of landfill impacts in the northeast backwater. I stirred up the sediment with a paddle at the furthest point of paddling; we did not observe any unusual odors or sheens in the sediment or water. The sediment had a peaty musty smell, as one would expect in wetlands. We also paddled short distances into the next [upstream] two backwater areas off the main channel, and saw no landfill impacts.

Photo #2: In Northeast Backwater; Phases 1 and 2 in background.

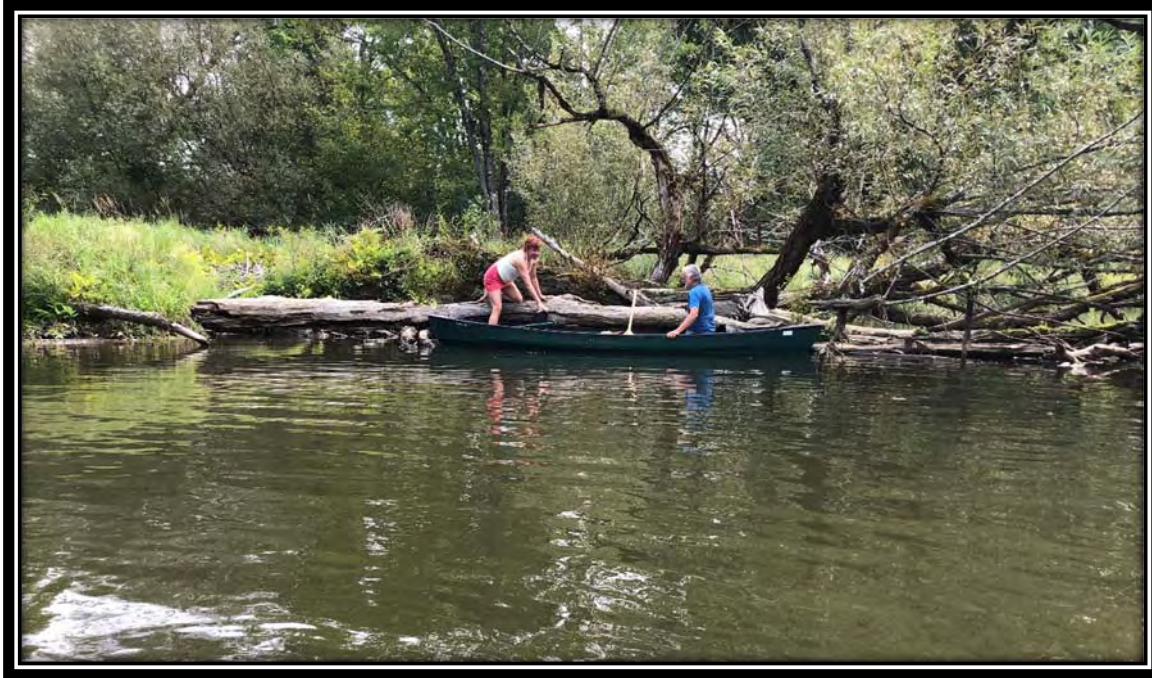
Trash observations: This year, we saw and collected a very small amount of trash – just enough to partially fill one 30-gallon trash bag. The trash we collected was mostly bottles, cans, and bits of Styrofoam. There was very little fishing-related trash. We saw no landfill-related trash in the water, along the banks, or in the trees; and there were very few signs of wind-blown trash anywhere along the route of our inspection.

Photo #3: Intrepid Laura Page collecting trash from blowdown in main river channel.

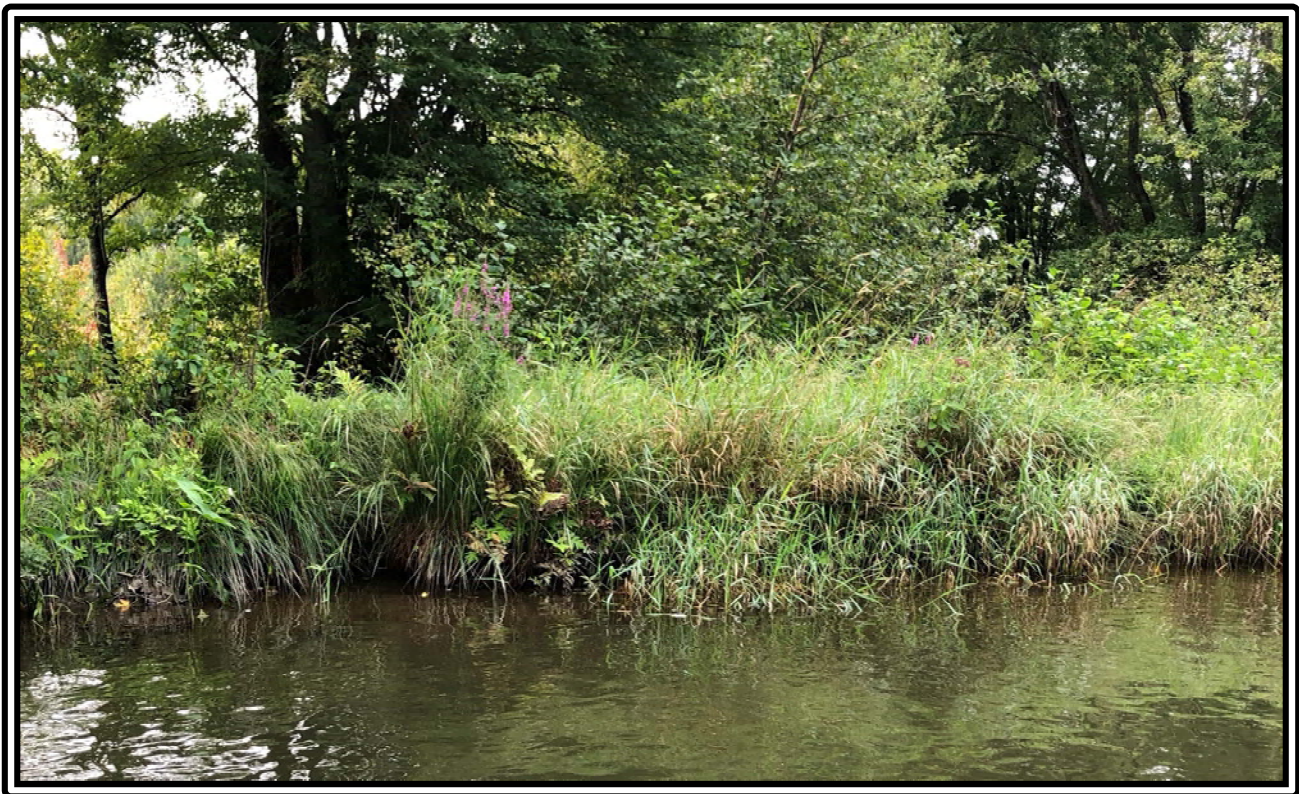
Vegetation: The shoreline vegetation appeared to be healthy and lush, with no apparent signs of landfill impacts. Similar to previous years, we saw very little purple loosestrife growing along the bank of the main river channel; we did notice a few very small stands of purple loosestrife in the three backwater areas that we paddled into [possibly not seen in previous years]. The cut stumps of invasive honeysuckle along the banks, from the removal effort by Northwoods Stewardship Center that was conducted in 2022, did not appear to be heavily re-sprouting. Very few areas of algal blooms were seen [fewer than usual]. Fewer than usual stands of Joe Pye Weed were seen. Jeff Parsons [ecologist from Arrowwood Environmental] pointed out bladderwort, marsh cinquefoil, arrowhead, wetland hemlock and other plant species that are common along river banks or in open wetlands such as here.

Photo #4: Typical river bank vegetation along main channel; water level was high enough today that very little bare riverbank sediment was exposed. Small stand of purple loosestrife in center of photo; quite rare along this stretch of river, and has not increased much over the 21 years of Black River inspection-by-boat trips.

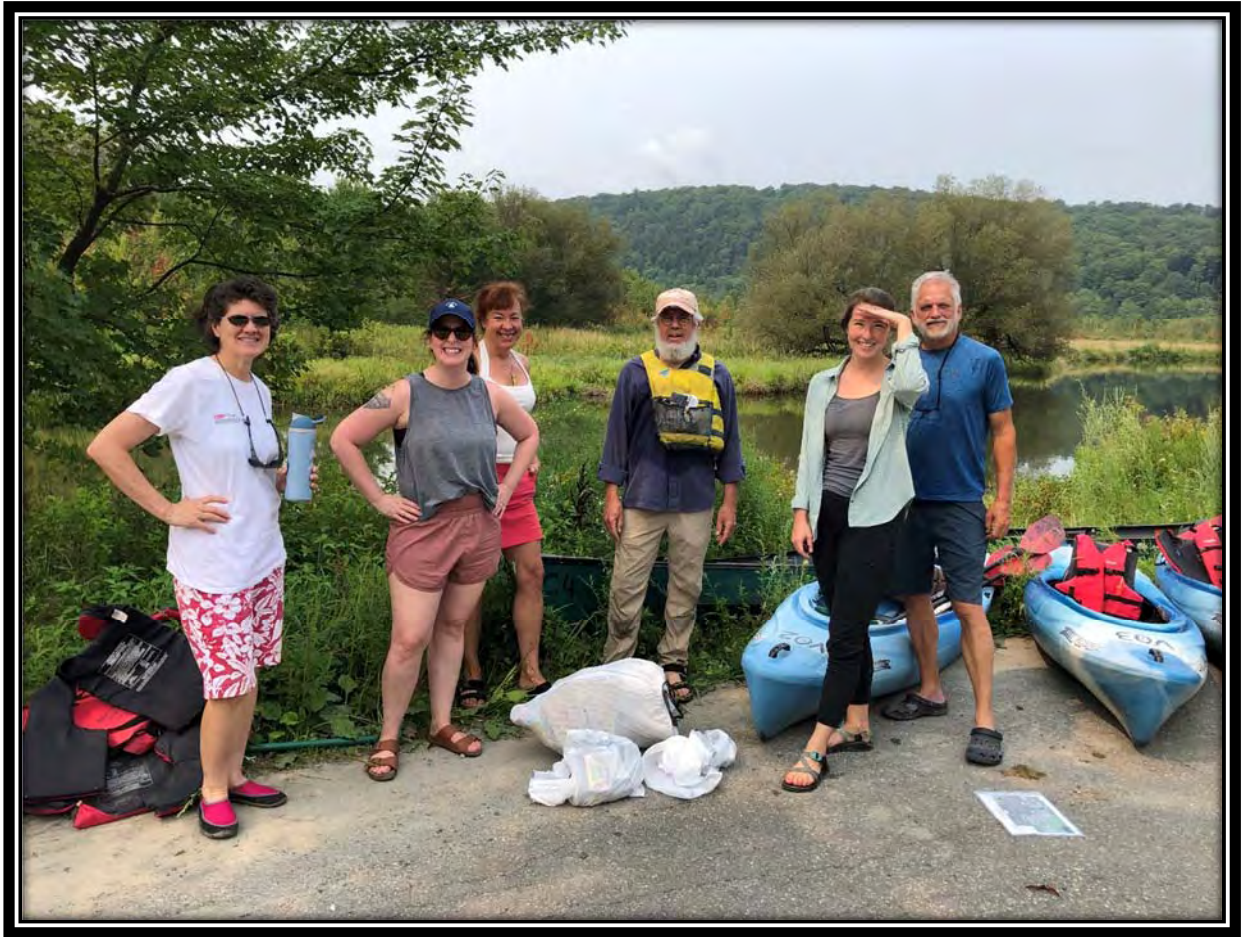
Photo #5: 2024 group [minus Lindsey Menard, taking the photo] at pullout – very little trash this year [white bags at our feet].
